## Home Inspection Report

**1355 Sage Hen Way #T, Sunnyvale**

Troy Raiburn  
September 23, 2019

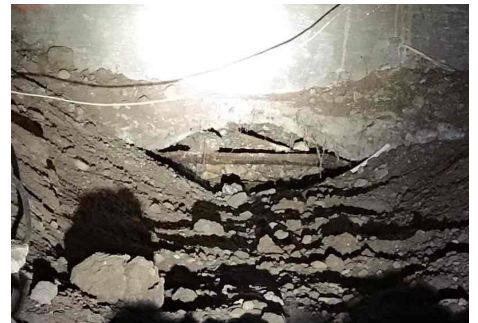
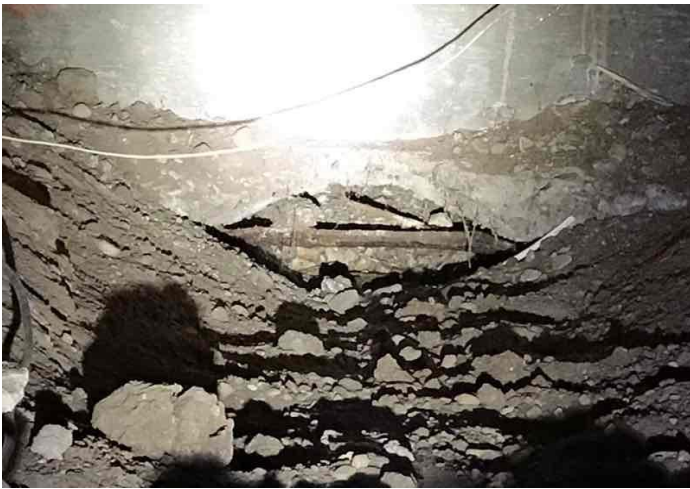
Photo 15

1. A section of the foundation with exposed rebar at the left rear wall crawl space have been undermined. If not addressed, should the soil give way under this area, a significant structural failure could develop. The owner is advised to contact the appropriate tradesperson. (See Photo 15)

- ! 1. A section of the foundation with exposed rebar at the left rear wall crawl space have been undermined. If not addressed, should the soil give way under this area, a significant structural failure could develop. The owner is advised to contact the appropriate tradesperson. (See Photo 15)

- 4. There is exposed reinforcing steel or anchor bolt at the left rear of the foundation as noted from the crawl space. We recommend all exposed steel be covered with material such as epoxy to prevent rust and subsequent foundation damage.

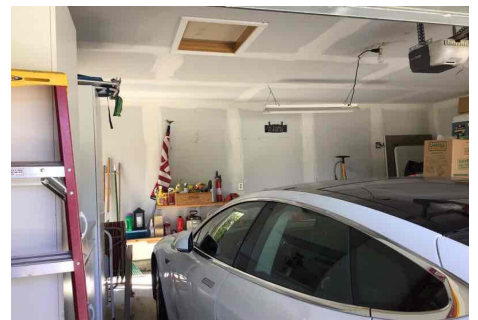
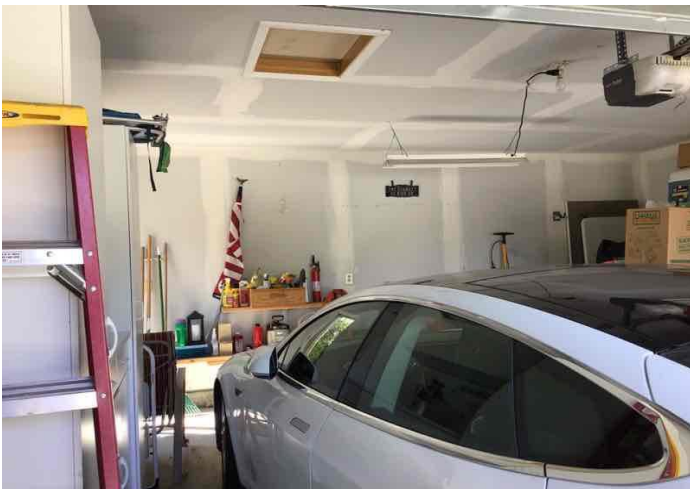
Photo 07

2. Personal vehicle was blocking the attic access opening in the garage, therefore, the garage attic space was not inspected. With access and an opportunity for a complete inspection, conditions in need of attention may be discovered. The personal belongings should be removed so the attic may be inspected. (See Photo 7)

- ! 2. Personal vehicle was blocking the attic access opening in the garage, therefore, the garage attic space was not inspected. With access and an opportunity for a complete inspection, conditions in need of attention may be discovered. The personal belongings should be removed so the attic may be inspected. (See Photo 7)

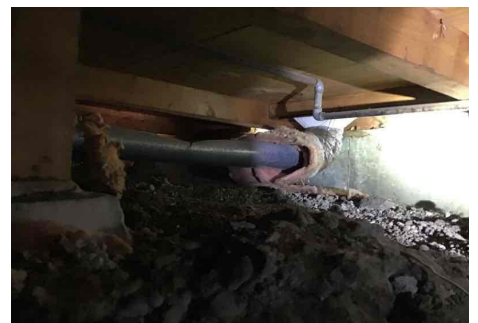
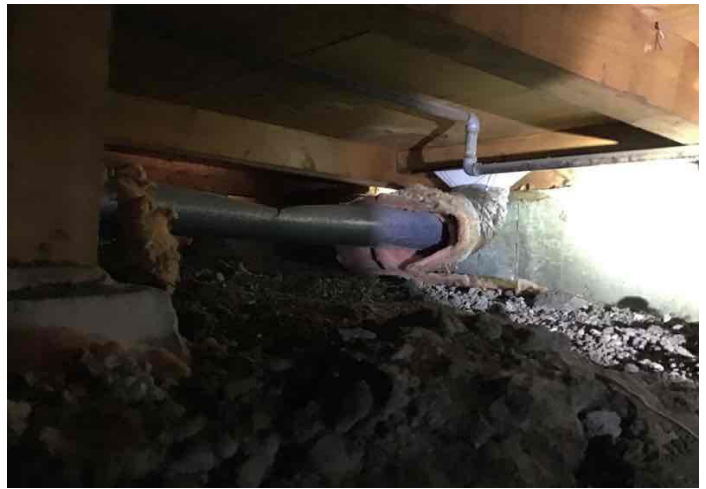
Photo 16

3. Due to the lack of clearance between the ground and ducting, plumbing, and/or floor joist/girders, portions of the crawl space at the front and left of the home were not inspected. With access and an opportunity for a complete inspection, conditions in need of attention may be discovered. We recommend further inspection when a minimum of 16 inches between the ground and any obstructions is provided. (See Photo 16)

Due to the lack of clearance between the ground and ducting, plumbing, and/or floor joist/girders, portions of the crawl space at the front and left of the home were not inspected. With access and an opportunity for a complete inspection, conditions in need of attention may be discovered. We recommend further inspection when a minimum of 16 inches between the ground and any obstructions is provided. (See Photo 16)

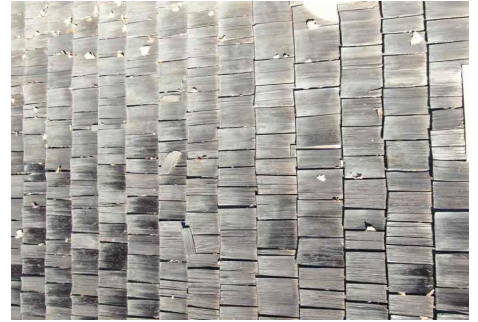
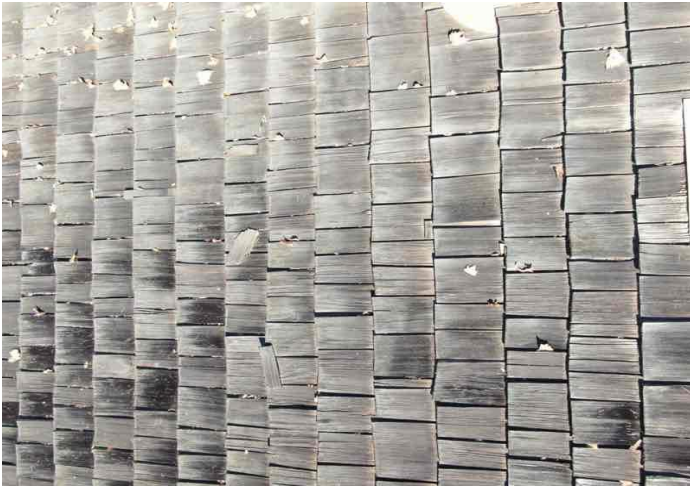
Photo 01

4. Repairs to the roof covering are recommended. Damaged, loose or missing roofing material should be repaired or replaced. All roof penetrations should be examined and sealed as necessary. For further evaluation of the condition of the roof we recommend you consult a licensed roofing contractor. (See Photo 1)  
(See Photo 2)

- ! 1. Repairs to the roof covering are recommended. Damaged, loose or missing roofing material should be repaired or replaced. All roof penetrations should be examined and sealed as necessary. For further evaluation of the condition of the roof we recommend you consult a licensed roofing contractor. (See Photo 1) (See Photo 2)
- ! 2. Missing downspouts at the garage gutters should be replaced as necessary. (See Photo 8)
- 3. Due to the height of the chimney and/or presence of a spark arrestor which was not removed during our examination, the interior of the chimney was not inspected. We recommend the advice and servicing of a licensed masonry contractor or fireplace specialist.

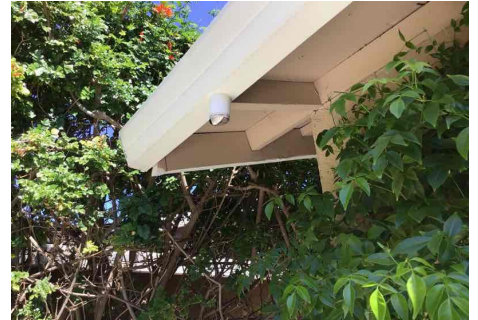
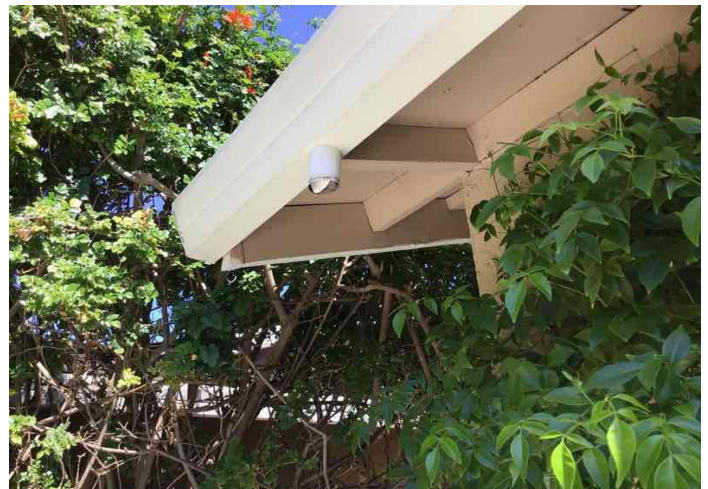
Photo 08

5. Missing downspouts at the garage gutters should be replaced as necessary.  
(See Photo 8)

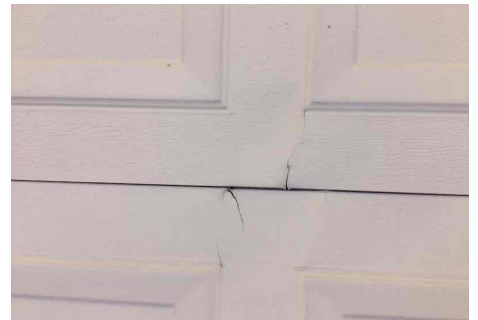
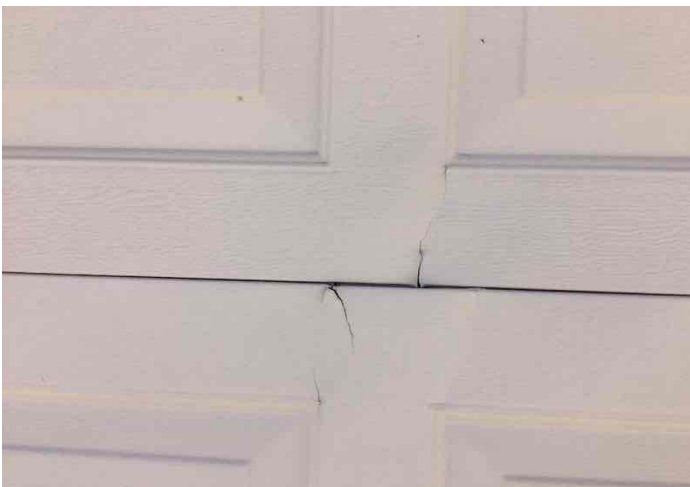
Photo 03

6. The main garage door is mechanically damaged. Repairs are recommended.  
(See Photo 3)

- ! 1. The main garage door is mechanically damaged. Repairs are recommended. (See Photo 3)
- ! 2. The main garage door jamb and/or trim shows evidence of water damage. We recommend the services of a licensed general contractor and/or structural pest control company regarding repairs. (See Photo 4)

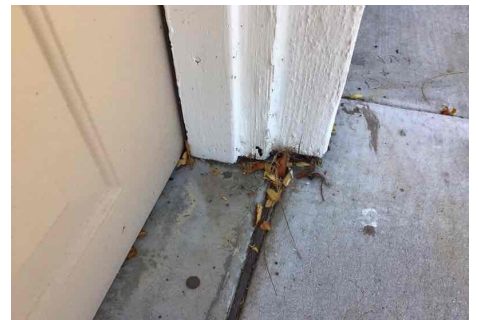
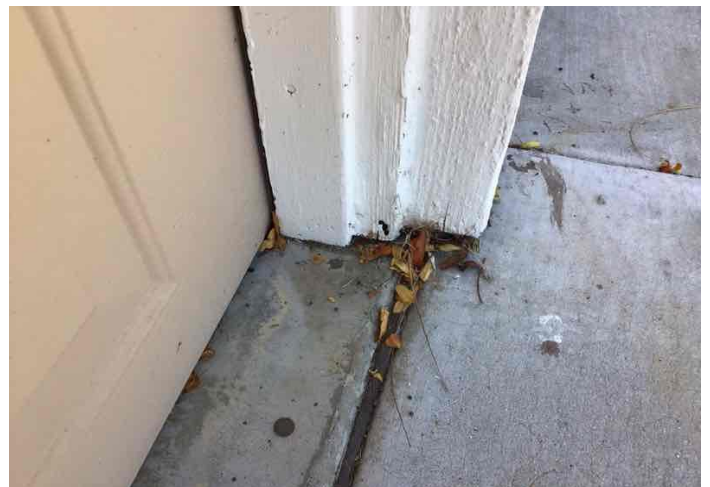
Photo 04

7. The main garage door jamb and/or trim shows evidence of water damage. We recommend the services of a licensed general contractor and/or structural pest control company regarding repairs. (See Photo 4)

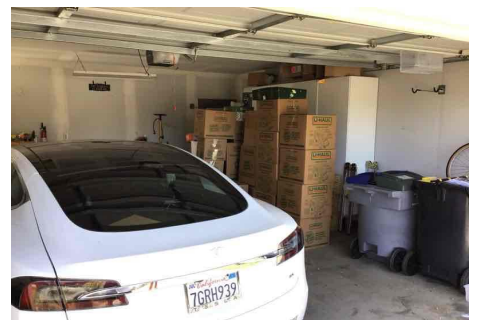
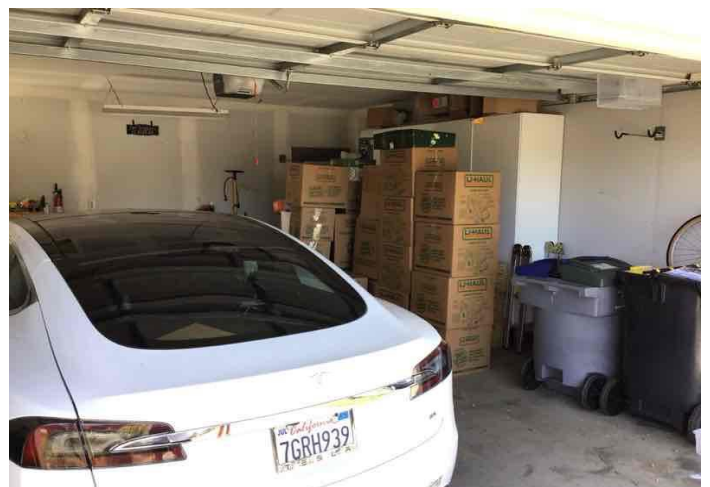
Photo 06

8. Personal storage was blocking access to the interior of the garage. Therefore, the area is considered inaccessible and was not fully inspected. With access and an opportunity for complete inspection, conditions in need of attention may be discovered. Ideally, the personal belongings should be removed so the area may be inspected. (See Photo 6)

Personal storage was blocking access to the interior of the garage. Therefore, the area is considered inaccessible and was not fully inspected. With access and an opportunity for complete inspection, conditions in need of attention may be discovered. Ideally, the personal belongings should be removed so the area may be inspected. (See Photo 6)

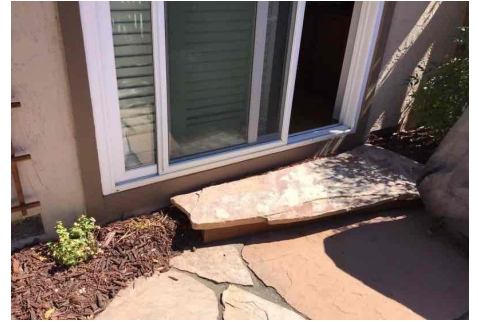
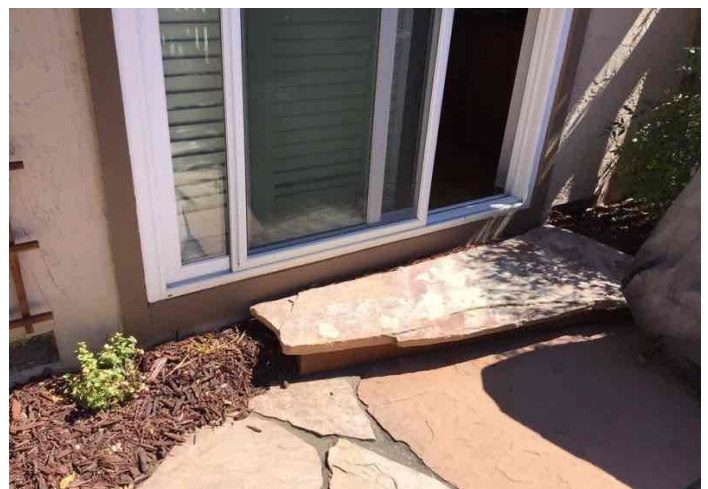
Photo 12

9. There is a faulty grade condition at the rear porch exterior wall. A faulty grade exists when the exterior grade is even with or above the foundation. We recommend this area be graded to maintain an earth level below the top of the foundation, so that water may drain away from the structure. (See Illustration 3Q) (See Photo 12)

- ! 3. There is a faulty grade condition at the rear porch exterior wall. A faulty grade exists when the exterior grade is even with or above the foundation. We recommend this area be graded to maintain an earth level below the top of the foundation, so that water may drain away from the structure. (See Illustration 3Q) (See Photo 12)

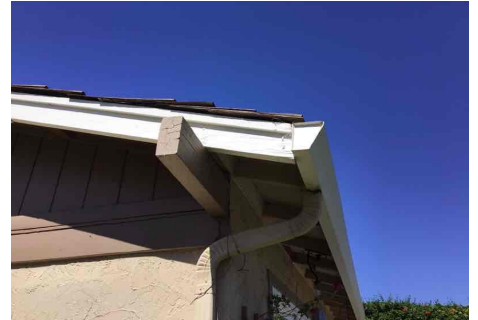
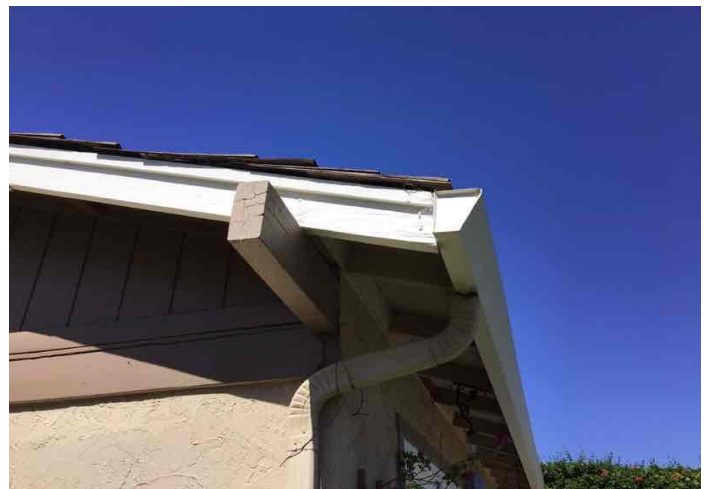
Photo 10

10. Damage was observed to the rafters at the front. We recommend the services of a licensed general contractor and/or structural pest control company. (See Photo 10)

- ! 4. Damage was observed to the rafters at the front. We recommend the services of a licensed general contractor and/or structural pest control company. (See Photo 10)

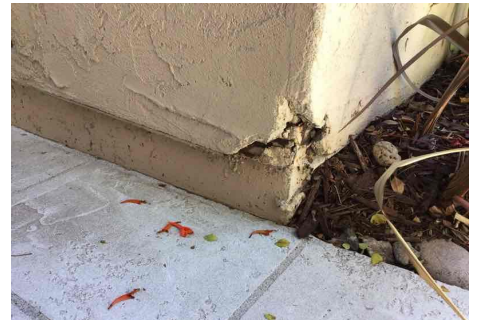
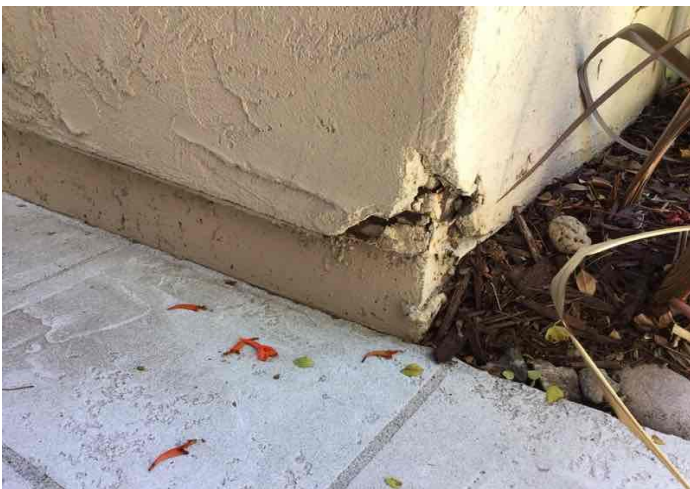
Photo 09

11. Localized damage and/or large stucco cracks at the garage should be further evaluated by the appropriate tradesperson to determine if any moisture intrusion has occurred and to repair the stucco in this area. (See Photo 9)

- ! 5. Localized damage and/or large stucco cracks at the garage should be further evaluated by the appropriate tradesperson to determine if any moisture intrusion has occurred and to repair the stucco in this area. (See Photo 9)

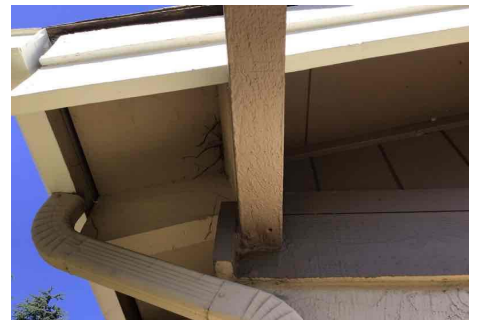
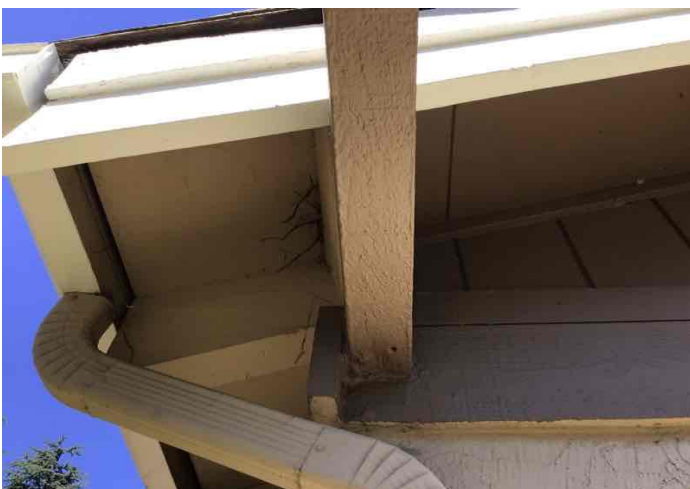
Photo 11

12. Damage was observed to the beam ends at the front. We recommend the services of a licensed general contractor and/or structural pest control company. (See Photo 11)

- ! 6. Damage was observed to the beam ends at the front. We recommend the services of a licensed general contractor and/or structural pest control company. (See Photo 11)

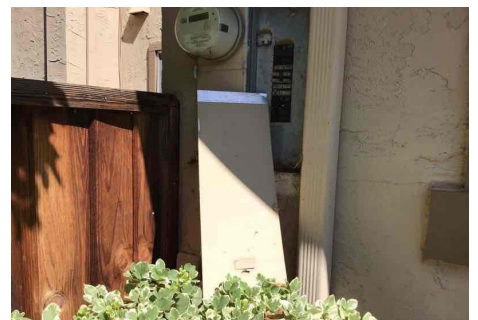
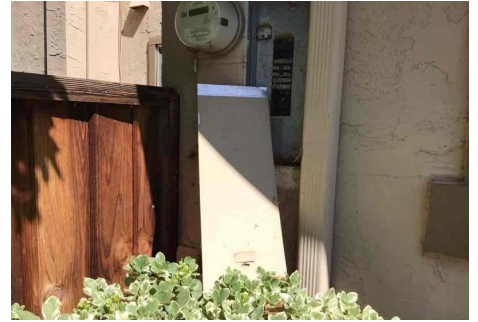
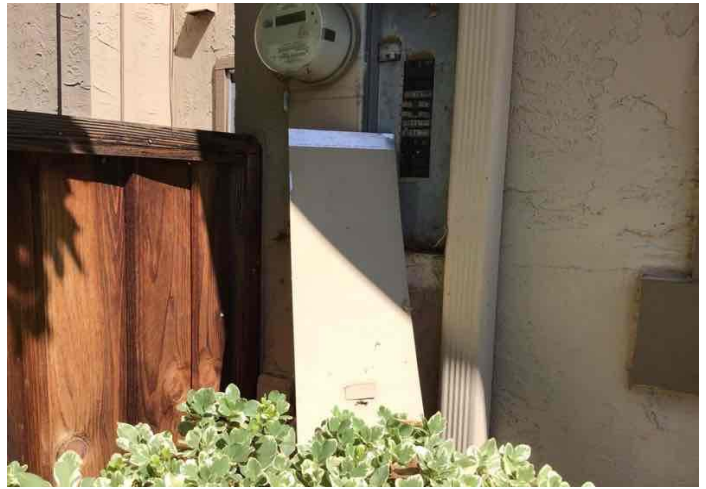
Photo 14

13. Evidence of periodic moisture entry/rust were noted in the interior of the main electrical panel. We recommend further evaluation and improvement of the panel by a licensed electrical contractor. (See Photo 14)

- 14. The main electric panel weatherproof cover plate is loose, damaged or missing. We recommend it be repaired or replaced. (See Photo 14)

- ! 1. Evidence of periodic moisture entry/rust were noted in the interior of the main electrical panel. We recommend further evaluation and improvement of the panel by a licensed electrical contractor. (See Photo 14)
- ! 2. The main electric panel weatherproof cover plate is loose, damaged or missing. We recommend it be repaired or replaced. (See Photo 14)
3. One or more of the lights in the den fan are inoperative. This may be due to turned off switches which were not located during our inspection. If the bulb has not failed or the lights switched off, the circuit should be investigated and repaired.
4. The "3 way" switch combination in the hallway is not functioning as intended. Either switch should have full control of the light fixture. This is a matter of convenience and is not a safety problem. Improvements would be optional. (See Illustration 4N)

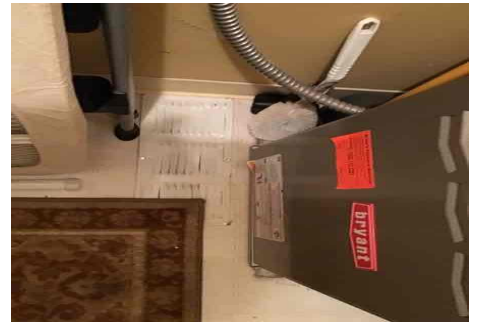
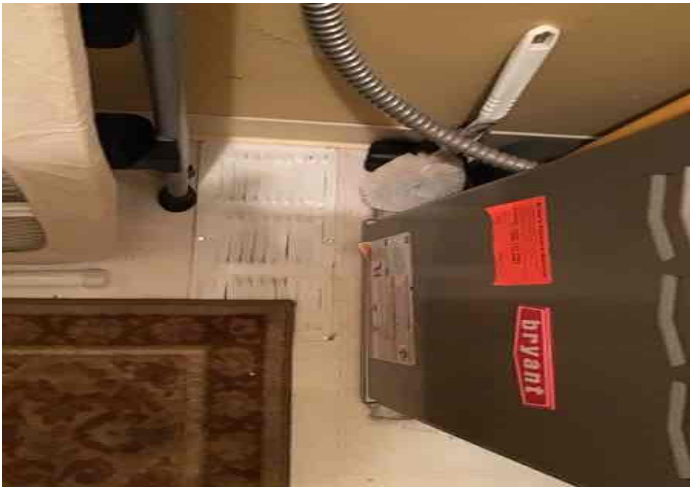
Photo 13

- 15. The combustion air and/or draft air upper and/or lower vents for the heating system appears to be clogged or covered. This condition limits proper cross ventilation. We recommend improvements. (See Photo 13)

- ! 1. The combustion air and/or draft air upper and/or lower vents for the heating system appears to be clogged or covered. This condition limits proper cross ventilation. We recommend improvements. (See Photo 13)
- ! 2. One or more of the ducts at the crawlspace are dented and/or damaged. We recommend repair. (See Photo 16) (See Photo 18)

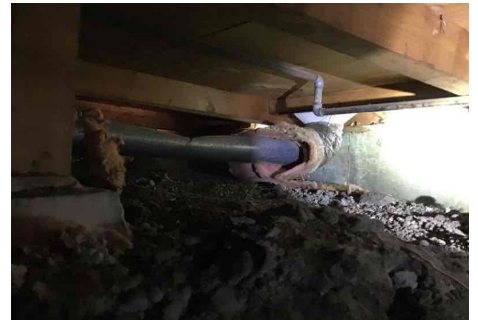
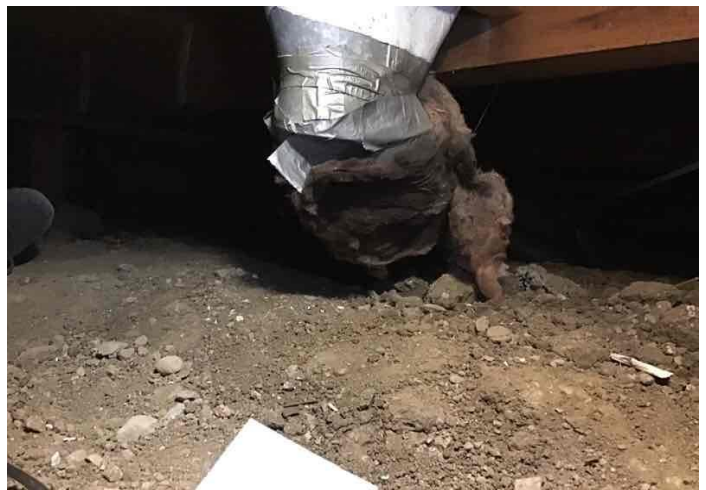
Photo 18

- 16. One or more of the ducts at the crawlspace are dented and/or damaged. We recommend repair. (See Photo 16) (See Photo 18)

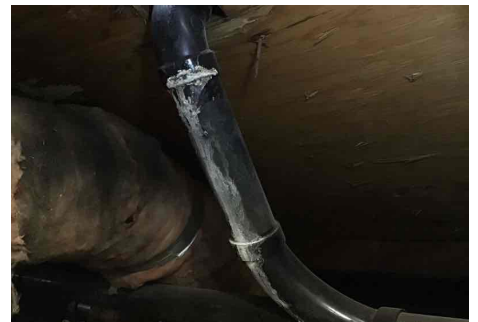
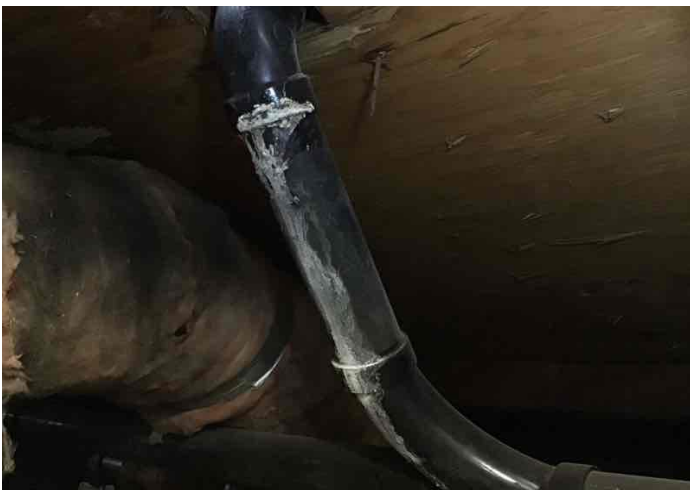
Photo 17

- 17. There is a cracked and leaking ABS drain pipe at the crawlspace under the laundry. This is a potential health hazard. We recommend the piping in question be repaired or replaced. (See Photo 17)

- The installation of a sediment trap at the water heater and furnace appliance gas line is recommended.
- ! 2. There is a cracked and leaking ABS drain pipe at the crawlspace under the laundry. This is a potential health hazard. We recommend the piping in question be repaired or replaced. (See Photo 17)**
- The shower faucet handles are loose at the master bathroom, and should be tightened.

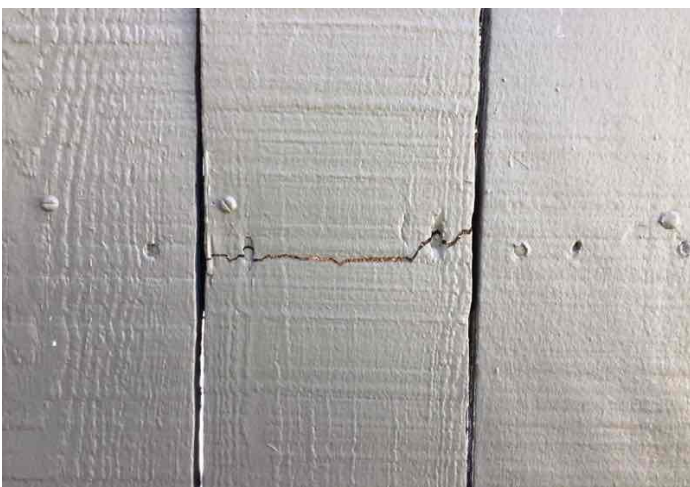
Photo 05

7. The fence gate at the garage needs minor repair. (See Photo 5)
8. There are some larger than normal sized cracks in the walkways. The cracks could be sealed for a better appearance and to prevent moisture intrusion.
